I98MI005

FOR ALL FORD MOTOR VEHICLES USING THROW OUT BEARING PART NUMBER N1714 OR O.E.M. TYPE EQUIVALENT DESIGN (PICTURED BELOW), WHICH IS A SELF ALIGNING TYPE THROWOUT BEARING.

FORD CARS AND TRUCKS

ALL FORD TRANSMISSIONS WITH ALUMINUM INPUT SHAFT RETAINER BEARING COLLAR

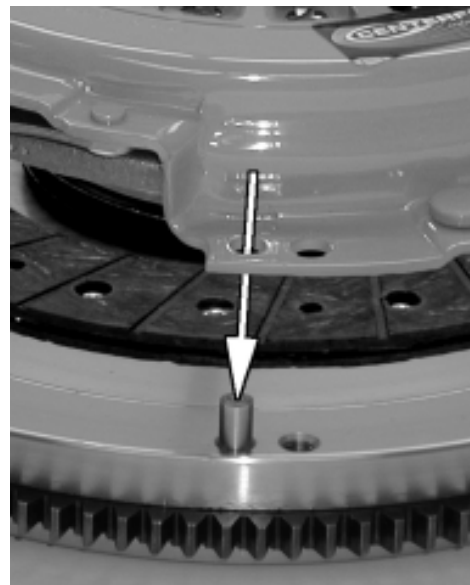
THE ALIGNMENT DOWEL PINS ARE USED TO PROPERLY LOCATE THE PRESSURE PLATE TO THE FLYWHEEL FOR BALANCE PURPOSES AS WELL AS TO ADD PRESSURE PLATE TO FLYWHEEL SHEAR STRENGTH. THE ALIGNMENT DOWEL PINS SHOULD ALWAYS BE REPLACED IF THEY ARE DAMAGED, BROKEN OFF, OR MISSING FROM THE FLYWHEEL.

FAILURE TO INSTALL OR REPLACE THE DOWEL PINS AS REQUIRED MAY RESULT IN CLUTCH VIBRATION, IMPROPER CLUTCH OPERATION, AND POSSIBLE CLUTCH FAILURE WHICH MAY VOID THE WARRANTY!

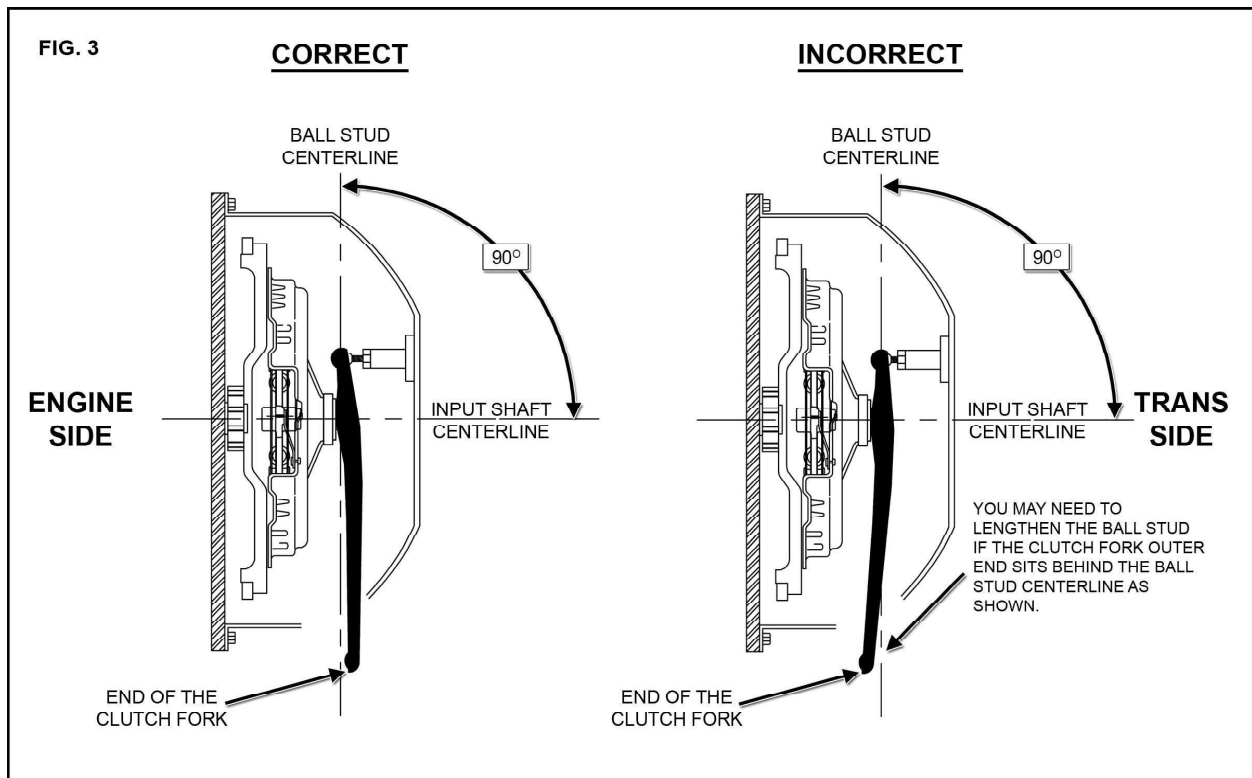
MECHANICAL CLUTCH LINKAGE GEOMETRY FINAL CHECK

Once the clutch assembly, release bearing, clutch fork and Bellhousing are bolted in place you can visually ensure the clutch fork ball stud is adjusted properly. Do not connect the remainder of the clutch linkage at this point. Move the clutch fork by hand until the release bearing contacts the clutch fingers. The outer end of the clutch fork should be pointed towards the transmission, behind the ball stud center as shown in FIG 3. If the outer end of the clutch fork is ahead of the ball stud centerline (pointing towards the engine), your clutch linkage is incorrect. Please re-visit the clutch fork pivot ball adjustment instructions or call the Centerforce Tech line at (928) 771-8422 for further assistance. Next, fully retract the release bearing away from the clutch fingers and visually check to insure that you have at least 1/4" clutch wear allowance gap between the release bearing and the clutch fingers. Once the geometry is correct, connect the remainder of the clutch linkage and then adjust to where the clutch engagement point is approximately half-way up the pedal travel. Small adjustments can be made to suit individual driving preferences. Throughout the service life of your clutch, be sure to periodically check the wear allowance gap and adjust as needed. Caution! If the clutch engagement point is at or near the top of your clutch pedal travel – your clutch may be pre-loaded (release bearing too close or touching the clutch fingers). Continued operation with the clutch in a pre-loaded condition will void the warranty and cause poor performance as well as significant damage.
