FOR ALL FORD MOTOR VEHICLES USING THROW OUT BEARING PART NUMBER N1714 OR O.E.M. TYPE EQUIVALENT DESIGN (PICTURED BELOW), WHICH IS A SELF ALIGNING TYPE THROWOUT BEARING.

FORD CARS AND TRUCKS

ALL FORD TRANSMISSIONS WITH ALUMINUM INPUT SHAFT RETAINER BEARING COLLAR

MUSTANG 5.0L AND 4.6L 1979-2004

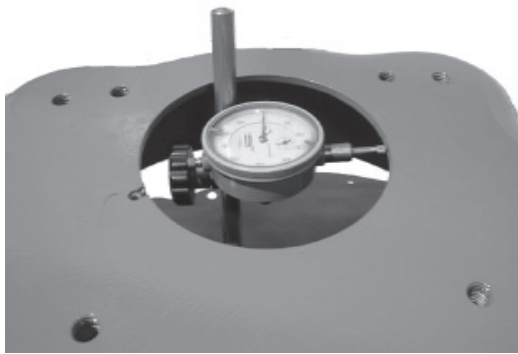
BELLHOUSING ALIGNMENT IS CRUCIAL FOR PROPER CLUTCH FUNCTION AND RELIABILITY OF THE RELATED COMPONENTS. DUE TO MANUFACTURING TOLERANCES OF ENGINE BLOCKS AND BELLHOUSINGS, IT IS POSSIBLE FOR THE TRANSMISSION CENTERLINE AND CRANKSHAFT CENTERLINE TO BE MISALIGNED. THE RESULT OF THIS MISALIGNMENT MAY BE HARD SHIFTING, PILOT BEARING WEAR, TRANSMISSION MAIN SHAFT BEARING WEAR AND FAILURE OF CLUTCH DISC HUB.

FIRST CHECK BELLHOUSING FOR BORE CONCENTRICITY. INSTALL MAGNETIC BASE TO FLYWHEEL OR PRESSURE PLATE, THEN INSTALL THE INDICATOR TO MEASURE THE BELLHOUSING BORE (SHOWN ABOVE). ROTATE THE CRANKSHAFT AND MARK DOWN THE INDICATOR READINGS (MARKING THE BELLHOUSING WORKS WELL). THE MAXIMUM OUT OF CONCENTRICITY IS .005".
