FOR ALL FORD MOTOR VEHICLES USING THROW OUT BEARING PART NUMBER N1714 OR O.E.M. TYPE EQUIVALENT DESIGN (PICTURED BELOW), WHICH IS A SELF ALIGNING TYPE THROWOUT BEARING.

FORD CARS AND TRUCKS

MUSTANG 5.0L AND 4.6L 1979-2004

FORD MUSTANGS WITH CABLE CLUTCH LINKAGE

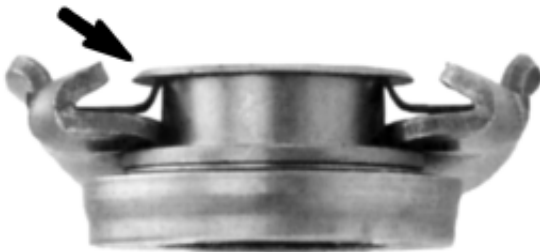
CORRECT

THE FORK SPRING CLIPS MUST BE INSTALLED BETWEEN THE THROWOUT BEARING COLLAR FLANGES. IF THE CLIPS ARE INSTALLED ABOVE THE TOP FLANGE AS SHOWN BELOW, PROPER ADJUSTMENT CANNOT BE MADE.

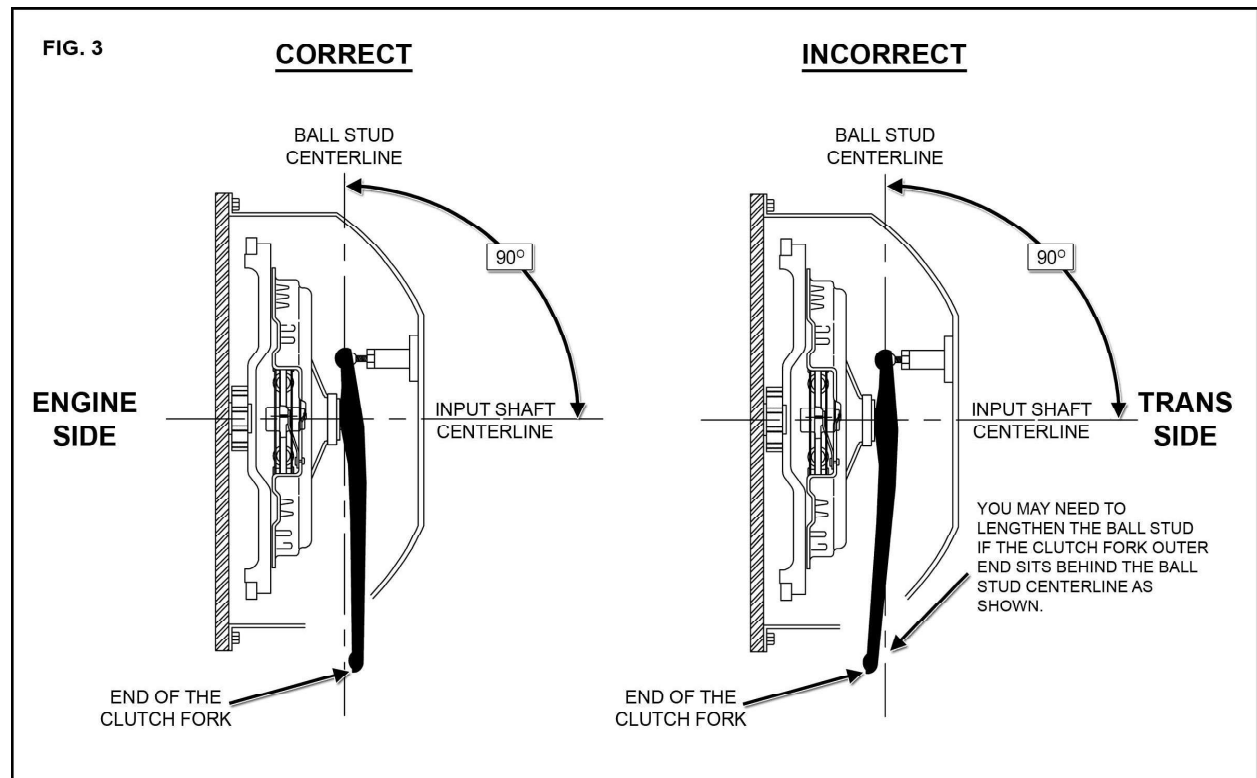
MECHANICAL CLUTCH LINKAGE GEOMETRY FINAL CHECK

Once the clutch assembly, release bearing, clutch fork and Bellhousing are bolted in place you can visually ensure the clutch fork ball stud is adjusted properly. Do not connect the remainder of the clutch linkage at this point. Move the clutch fork by hand until the release bearing contacts the clutch fingers. The outer end of the clutch fork should be pointed towards the transmission, behind the ball stud center as shown in FIG 3. If the outer end of the clutch fork is ahead of the ball stud centerline (pointing towards the engine), your clutch linkage is incorrect. Please re-visit the clutch fork pivot ball adjustment instructions or call the Centerforce Tech line at (928) 771-8422 for further assistance. Next, fully retract the release bearing away from the clutch fingers and visually check to insure that you have at least 1/4" clutch wear allowance gap between the release bearing and the clutch fingers. Once the geometry is correct, connect the remainder of the clutch linkage and then adjust to where the clutch engagement point is approximately half-way up the pedal travel. Small adjustments can be made to suit individual driving preferences. Throughout the service life of your clutch, be sure to periodically check the wear allowance gap and adjust as needed. Caution! If the clutch engagement point is at or near the top of your clutch pedal travel – your clutch may be pre-loaded (release bearing too close or touching the clutch fingers). Continued operation with the clutch in a pre-loaded condition will void the warranty and cause poor performance as well as significant damage.
