GENERAL BELLHOUSING ALIGNMENT INSTRUCTIONS

IMPORTANT

DODGE, CHRYSLER & PLYMOUTH VEHICLES

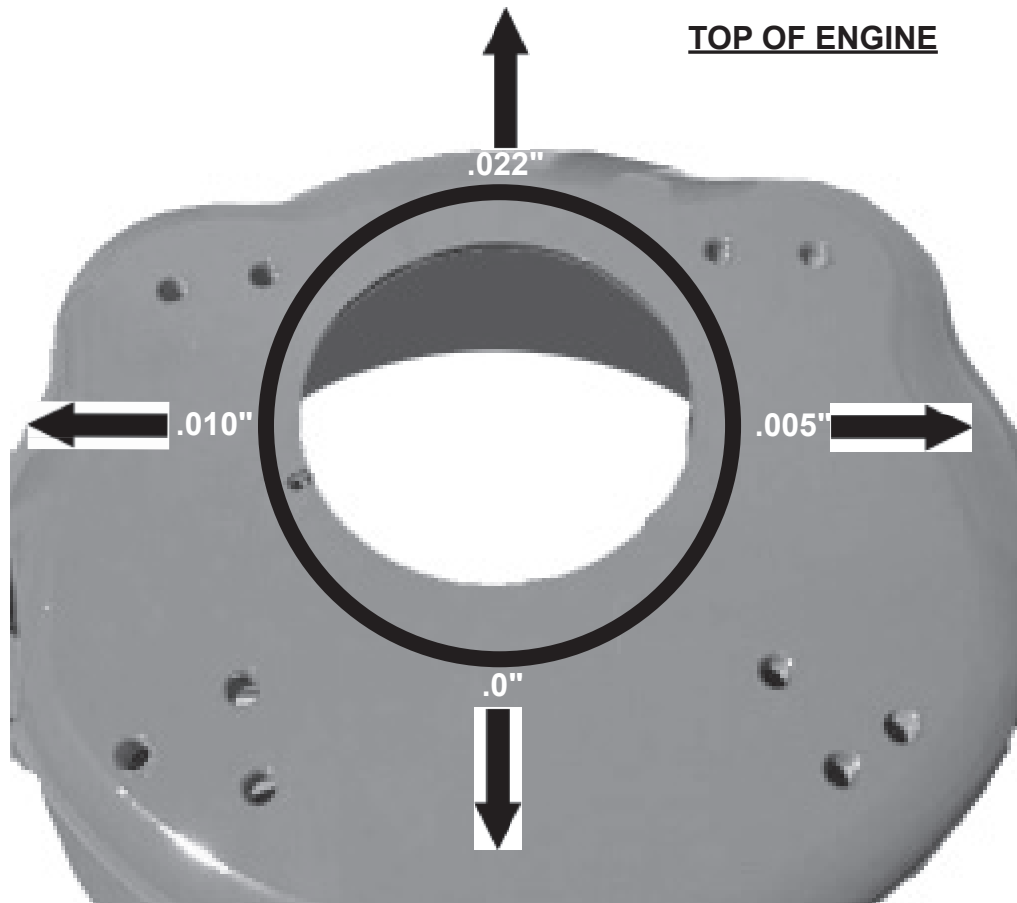
EXAMPLE

THE BELLHOUSING WAS OFFSET TOWARD TOP OF ENGINE AND SLIGHTLY TO THE LEFT (AS VIEWED FROM BEHIND). TO ALIGN THE BELLHOUSING, INSTALL TWO .014" OFFSET DOWEL PINS WITH THE MAXIMUM OFFSET POSITIONED ROUGHLY AT THE 5 O'CLOCK POSITION.

TO CORRECT OFF-CENTER CONDITION, SELECT THE OFFSET DOWEL PIN PAIR THAT IS CLOSEST TO ONE-HALF OF THE INDICATOR READING (I.E., IF READING IS .016", 1/2R=.008" USE .007" DOWELS. IF READING IS .024", 1/2R=.012" USE .014 DOWELS).
