FOR ALL FORD MOTOR VEHICLES USING THROW OUT BEARING PART NUMBER N1714 OR O.E.M. TYPE EQUIVALENT DESIGN (PICTURED BELOW), WHICH IS A SELF ALIGNING TYPE THROWOUT BEARING.

FORD CARS AND TRUCKS

ALL FORD TRANSMISSIONS WITH ALUMINUM INPUT SHAFT RETAINER BEARING COLLAR

MUSTANG 5.0L AND 4.6L 1979-2004

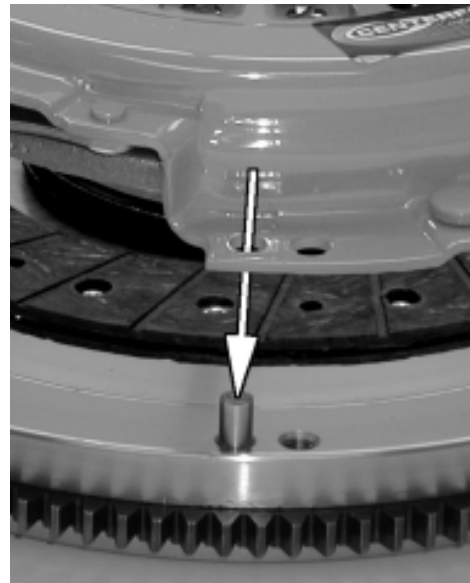
THE ALIGNMENT DOWEL PINS ARE USED TO PROPERLY LOCATE THE PRESSURE PLATE TO THE FLYWHEEL FOR BALANCE PURPOSES AS WELL AS TO ADD PRESSURE PLATE TO FLYWHEEL SHEAR STRENGTH. THE ALIGNMENT DOWEL PINS SHOULD ALWAYS BE REPLACED IF THEY ARE DAMAGED, BROKEN OFF, OR MISSING FROM THE FLYWHEEL.

FAILURE TO INSTALL OR REPLACE THE DOWEL PINS AS REQUIRED MAY RESULT IN CLUTCH VIBRATION, IMPROPER CLUTCH OPERATION, AND POSSIBLE CLUTCH FAILURE WHICH MAY VOID THE WARRANTY!

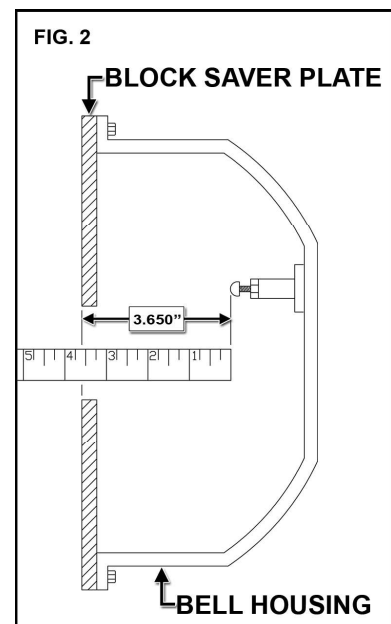
FIG 2 shows the O.E. clutch fork pivot ball height of 3.650” as measured from the engine block side of the Bellhousing plate (block saver) to the top of the clutch fork pivot ball. If your flywheel deck height measures between 0.910” and 0.960”, be sure your clutch fork pivot ball height is 3.650”. If your flywheel deck height is less than 0.910” you will need to adjust the clutch fork pivot ball height to accommodate the thinner flywheel as follows:

- 1) If your flywheel deck height thickness is significantly below the O.E. specification, the clutch disc springs may contact the flywheel crankshaft bolts resulting in improper or failed clutch operation.
- 2) Centerforce DOES NOT recommend any shims/spacers or aftermarket balance plates to be used between the crankshaft and the flywheel.

Enter your flywheel Deck Height measurement here: _____ and SUBTRACT from 0.960” (O.E. standard flywheel deck height) = “Pivot ball adjustment distance”.

Then: SUBTRACT “Pivot ball adjustment distance” from 3.650” (O.E. standard pivot ball height) to find the correct clutch fork pivot ball height.

Use an aftermarket adjustable pivot ball to move the clutch fork pivot ball 0.110” CLOSER to the engine:

0.110” SUBTRACT from 3.650” = 3.540” (adjust the clutch fork pivot ball height to 3.540” in this example.)
