FOR ALL FORD MOTOR VEHICLES USING THROW OUT BEARING PART NUMBER N1714 OR O.E.M. TYPE EQUIVALENT DESIGN (PICTURED BELOW), WHICH IS A SELF ALIGNING TYPE THROWOUT BEARING.

FORD CARS AND TRUCKS

ALL FORD TRANSMISSIONS WITH ALUMINUM INPUT SHAFT RETAINER BEARING COLLAR

MUSTANG 5.0L AND 4.6L 1979-2004

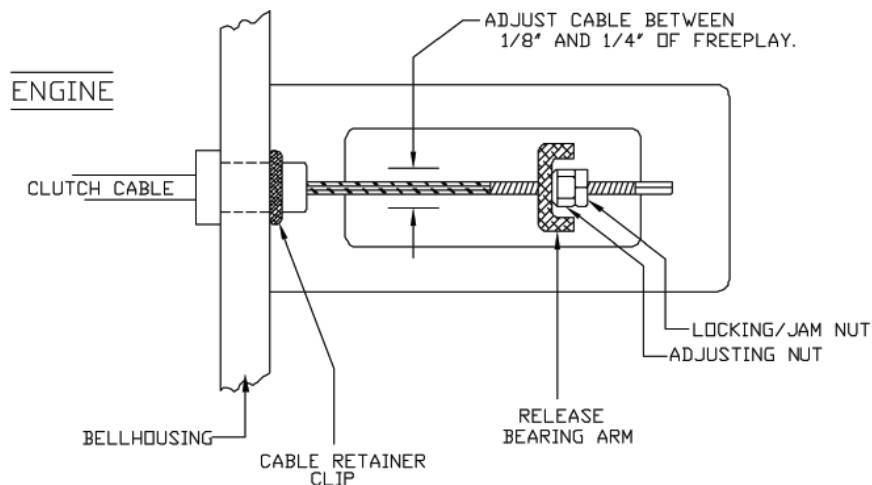
ADJUSTMENT DIAGRAM FOR ADJUSTABLE QUADRANT

CARS WITH AN AFTER MARKET (ONE PIECE) ADJUSTABLE QUADRANT- (MANUAL ADJUSTMENT). MOVE THE CABLE ADJUSTING NUT (AT THE RELEASE BEARING ARM) TO OBTAIN 1/8" MINIMUM TO 1/4" OF FREEPLAY IN THE CABLE (SEE DIAGRAM). AT THIS SETTING THE CLUTCH SHOULD ENGAGE AT ONE THIRD TO ONE HALF OF THE PEDAL TRAVEL DISTANCE UP FROM THE FLOOR BOARD. IF THE ENGAGEMENT POINT DOES NOT FALL WITHIN THIS RANGE; LOOSEN THE ADJUSTING NUT (ADD SLACK TO THE CABLE) TO LOWER THE POINT OF ENGAGEMENT, OR THE OPPOSITE, TIGHTEN THE CABLE (MAKING SURE TO MAINTAIN THE PROPER FREEPLAY IN THE CABLE), TO RAISE THE ENGAGEMENT POINT UNTIL THE PROPER SETTING IS ACHIEVED. BE SURE TO LOCK THE CABLE ADJUSTING NUT WITH THE JAM NUT WHEN THE ADJUSTMENT IS COMPLETED.
