FOR ALL FORD MOTOR VEHICLES USING THROW OUT BEARING PART NUMBER N1714 OR O.E.M. TYPE EQUIVALENT DESIGN (PICTURED BELOW), WHICH IS A SELF ALIGNING TYPE THROWOUT BEARING.

GENERAL BELLHOUSING ALIGNMENT INSTRUCTIONS

ALL FORD TRANSMISSIONS WITH ALUMINUM INPUT SHAFT RETAINER BEARING COLLAR

MUSTANG 5.0L AND 4.6L 1979-2004

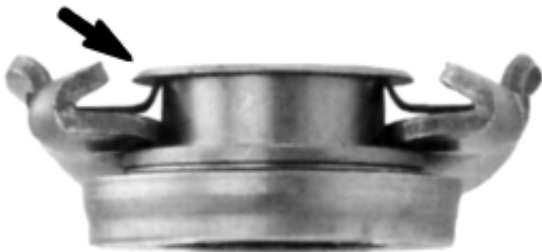
CORRECT

THE FORK SPRING CLIPS MUST BE INSTALLED BETWEEN THE THROWOUT BEARING COLLAR FLANGES. IF THE CLIPS ARE INSTALLED ABOVE THE TOP FLANGE AS SHOWN BELOW, PROPER ADJUSTMENT CANNOT BE MADE.

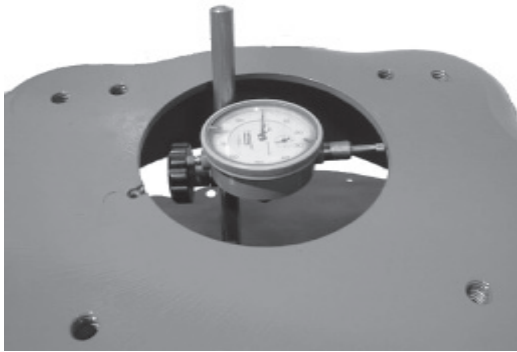
BELLHOUSING ALIGNMENT IS CRUCIAL FOR PROPER CLUTCH FUNCTION AND RELIABILITY OF THE RELATED COMPONENTS. DUE TO MANUFACTURING TOLERANCES OF ENGINE BLOCKS AND BELLHOUSINGS, IT IS POSSIBLE FOR THE TRANSMISSION CENTERLINE AND CRANKSHAFT CENTERLINE TO BE MISALIGNED. THE RESULT OF THIS MISALIGNMENT MAY BE HARD SHIFTING, PILOT BEARING WEAR, TRANSMISSION MAIN SHAFT BEARING WEAR AND FAILURE OF CLUTCH DISC HUB.

FIRST CHECK BELLHOUSING FOR BORE CONCENTRICITY. INSTALL MAGNETIC BASE TO FLYWHEEL OR PRESSURE PLATE, THEN INSTALL THE INDICATOR TO MEASURE THE BELLHOUSING BORE (SHOWN ABOVE). ROTATE THE CRANKSHAFT AND MARK DOWN THE INDICATOR READINGS (MARKING THE BELLHOUSING WORKS WELL). THE MAXIMUM OUT OF CONCENTRICITY IS .005".

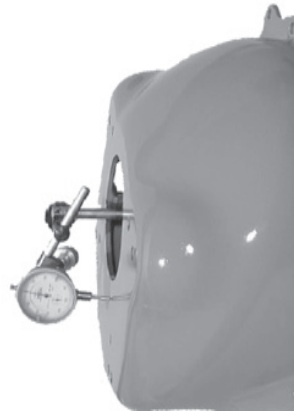
NEXT, THE BELLHOUSING FACE SHOULD BE CHECKED FOR PARALLELISM TO THE BACK OF THE BLOCK. INSTALL THE INDICATOR (AS SHOWN ABOVE). ROTATE THE CRANKSHAFT AND MARK DOWN THE READINGS (BE SURE TO PUSH THE CRANKSHAFT AGAINST THRUST BEARING FOR ACCURATE MEASUREMENT). THE MAXIMUM OUT OF PARALLELISM IS .002"

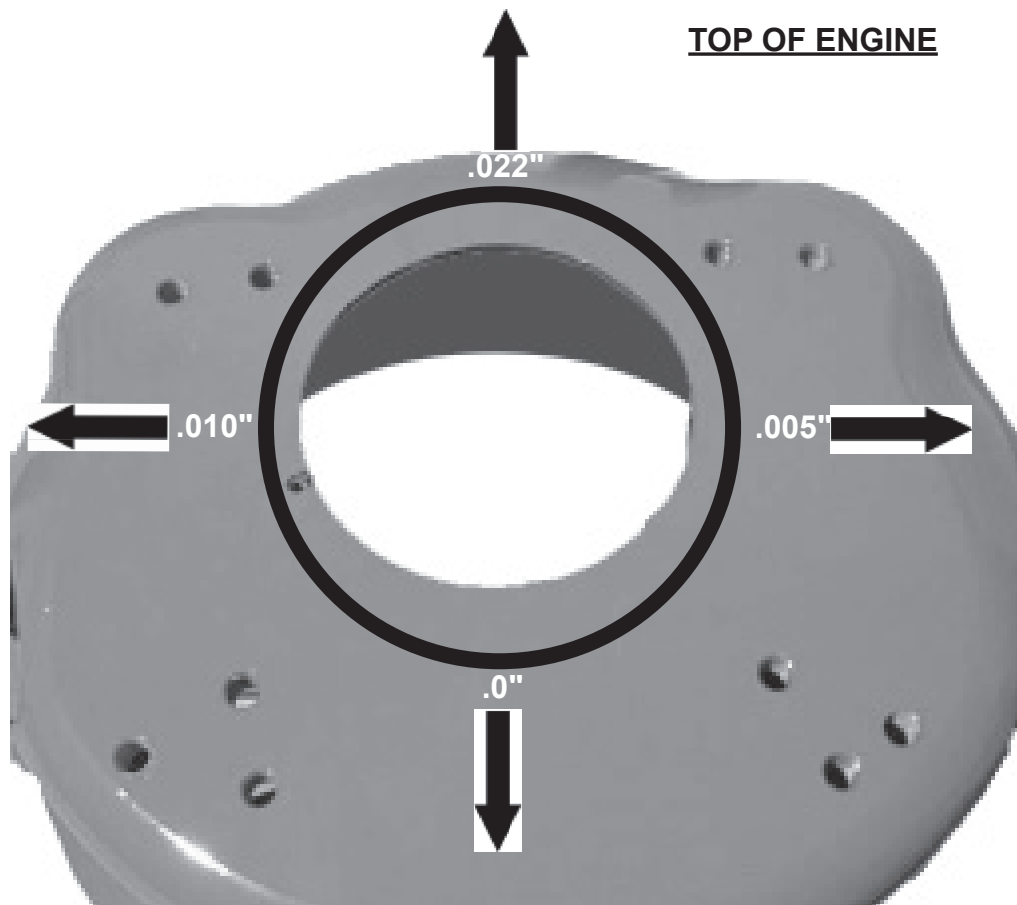
EXAMPLE

THE BELLHOUSING WAS OFFSET TOWARD TOP OF ENGINE AND SLIGHTLY TO THE LEFT (AS VIEWED FROM BEHIND). TO ALIGN THE BELLHOUSING, INSTALL TWO .014" OFFSET DOWEL PINS WITH THE MAXIMUM OFFSET POSITIONED ROUGHLY AT THE 5 O'CLOCK POSITION.

TO CORRECT OFF-CENTER CONDITION, SELECT THE OFFSET DOWEL PIN PAIR THAT IS CLOSEST TO ONE-HALF OF THE INDICATOR READING (I.E., IF READING IS .016", 1/2R=.008" USE .007" DOWELS. IF READING IS .024", 1/2R=.012" USE .014 DOWELS).

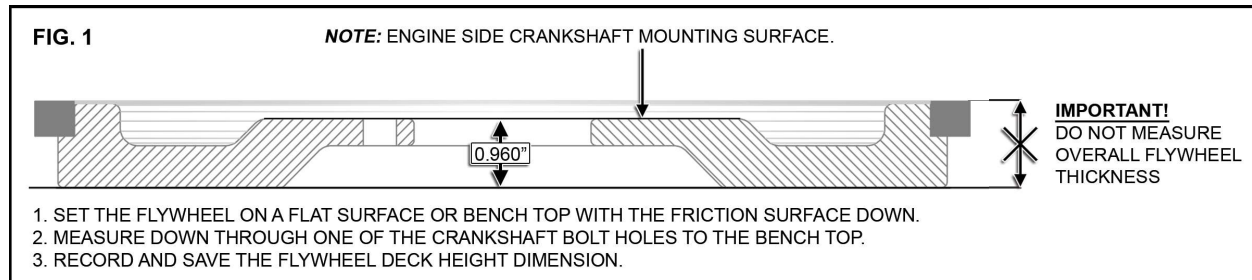
To help achieve proper cable clutch linkage geometry, you will need to measure your flywheel deck height (distance from the flywheel crankshaft flange surface to the clutch friction surface) as shown in FIG 1. Aftermarket flywheel variances and/or flywheel resurfacing may have reduced your flywheel deck height from the Original Equipment (O.E.) flywheel measurement of 0.960”.

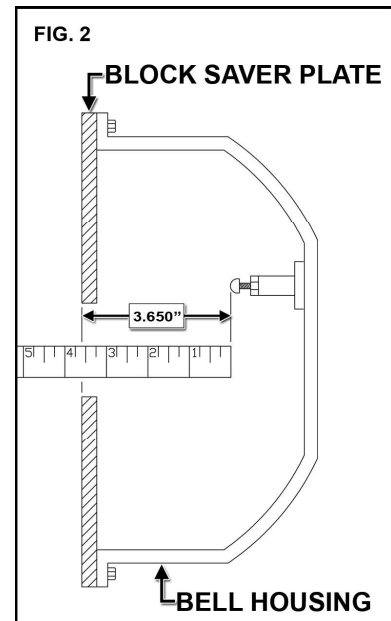
FIG 2 shows the O.E. clutch fork pivot ball height of 3.650” as measured from the engine block side of the Bellhousing plate (block saver) to the top of the clutch fork pivot ball. If your flywheel deck height measures between 0.910” and 0.960”, be sure your clutch fork pivot ball height is 3.650”. If your flywheel deck height is less than 0.910” you will need to adjust the clutch fork pivot ball height to accommodate the thinner flywheel as follows:

- 1) If your flywheel deck height thickness is significantly below the O.E. specification, the clutch disc springs may contact the flywheel crankshaft bolts resulting in improper or failed clutch operation.
- 2) Centerforce DOES NOT recommend any shims/spacers or aftermarket balance plates to be used between the crankshaft and the flywheel.

Use an aftermarket adjustable pivot ball to move the clutch fork pivot ball 0.110” CLOSER to the engine:

0.110” SUBTRACT from 3.650” = 3.540” (adjust the clutch fork pivot ball height to 3.540” in this example.)

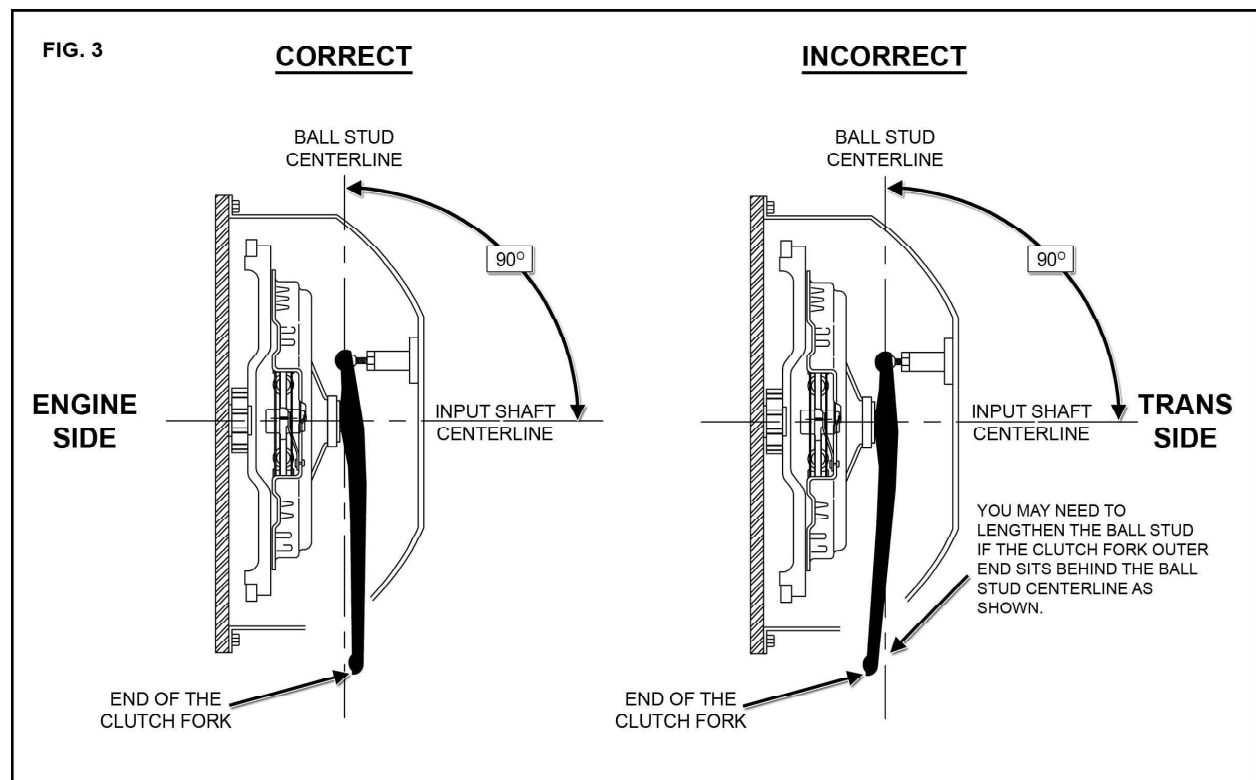
MECHANICAL CLUTCH LINKAGE GEOMETRY FINAL CHECK

Once the clutch assembly, release bearing, clutch fork and Bellhousing are bolted in place you can visually ensure the clutch fork ball stud is adjusted properly. Do not connect the remainder of the clutch linkage at this point. Move the clutch fork by hand until the release bearing contacts the clutch fingers. The outer end of the clutch fork should be pointed towards the transmission, behind the ball stud center as shown in FIG 3. If the outer end of the clutch fork is ahead of the ball stud centerline (pointing towards the engine), your clutch linkage is incorrect. Please re-visit the clutch fork pivot ball adjustment instructions or call the Centerforce Tech line at (928) 771-8422 for further assistance. Next, fully retract the release bearing away from the clutch fingers and visually check to insure that you have at least 1/4" clutch wear allowance gap between the release bearing and the clutch fingers. Once the geometry is correct, connect the remainder of the clutch linkage and then adjust to where the clutch engagement point is approximately half-way up the pedal travel. Small adjustments can be made to suit individual driving preferences. Throughout the service life of your clutch, be sure to periodically check the wear allowance gap and adjust as needed. Caution! If the clutch engagement point is at or near the top of your clutch pedal travel – your clutch may be pre-loaded (release bearing too close or touching the clutch fingers). Continued operation with the clutch in a pre-loaded condition will void the warranty and cause poor performance as well as significant damage.
