FOR ALL FORD MOTOR VEHICLES USING THROW OUT BEARING PART NUMBER N1714 OR O.E.M. TYPE EQUIVALENT DESIGN (PICTURED BELOW), WHICH IS A SELF ALIGNING TYPE THROWOUT BEARING.

FORD CARS AND TRUCKS

ALL FORD TRANSMISSIONS WITH ALUMINUM INPUT SHAFT RETAINER BEARING COLLAR

MUSTANG 5.0L AND 4.6L 1979-2004

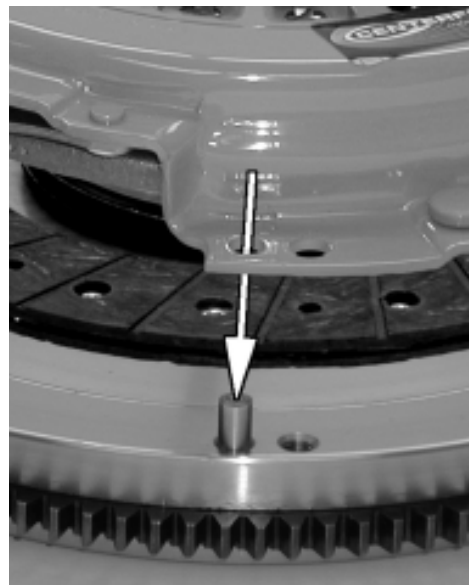
YOUR NEW CENTERFORCE® CLUTCH ASSEMBLY AND FLYWHEEL HAVE BEEN DESIGNED TO BE USED WITH LOCATING DOWEL PINS.

THE ALIGNMENT DOWEL PINS ARE USED TO PROPERLY LOCATE THE PRESSURE PLATE TO THE FLYWHEEL FOR BALANCE PURPOSES AS WELL AS TO ADD PRESSURE PLATE TO FLYWHEEL SHEAR STRENGTH. THE ALIGNMENT DOWEL PINS SHOULD ALWAYS BE REPLACED IF THEY ARE DAMAGED, BROKEN OFF, OR MISSING FROM THE FLYWHEEL.

FAILURE TO INSTALL OR REPLACE THE DOWEL PINS AS REQUIRED MAY RESULT IN CLUTCH VIBRATION, IMPROPER CLUTCH OPERATION, AND POSSIBLE CLUTCH FAILURE WHICH MAY VOID THE WARRANTY!
